# CASE STUDY

## UNDER HOUSE SEEPAGE FLOODING

**Location:** Paddington, Brisbane

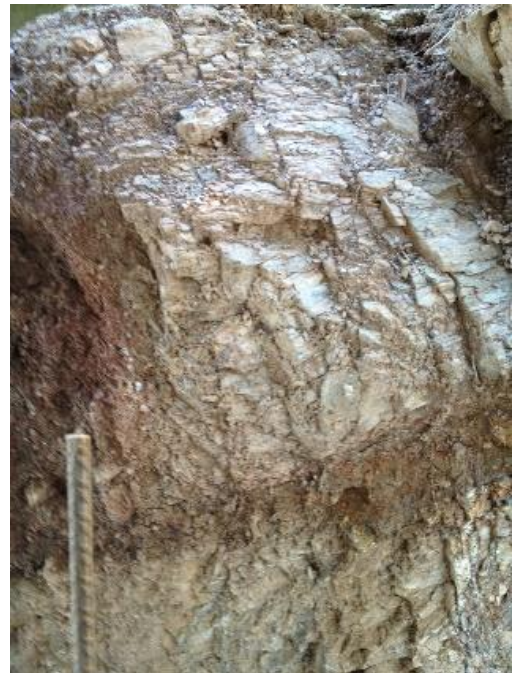
Note the fractured rock strata through groundwater runs freely.

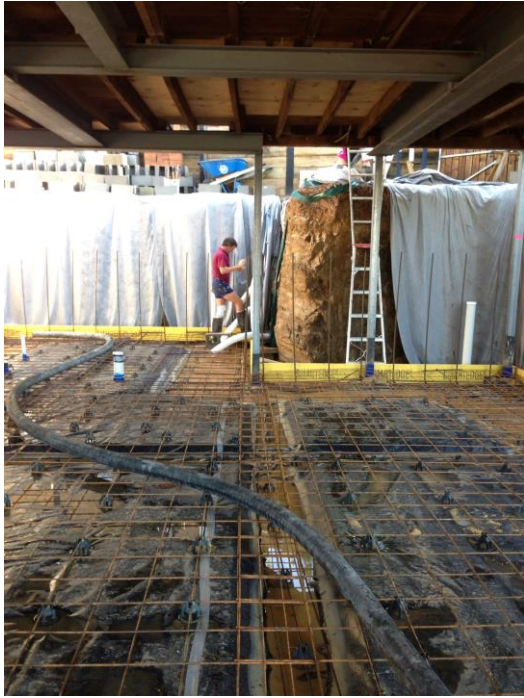
The slab ready for pouring. Note that the Capiphon has been covered with more coarse sand and plastic sheeting before the reinforcing has been laid.

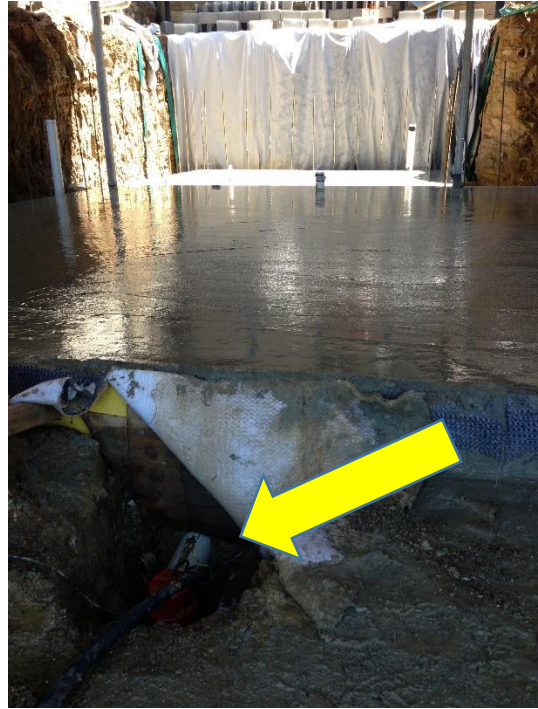
The slab immediately after pouring. Note the discharge pipe (arrow) exiting from under the slab.

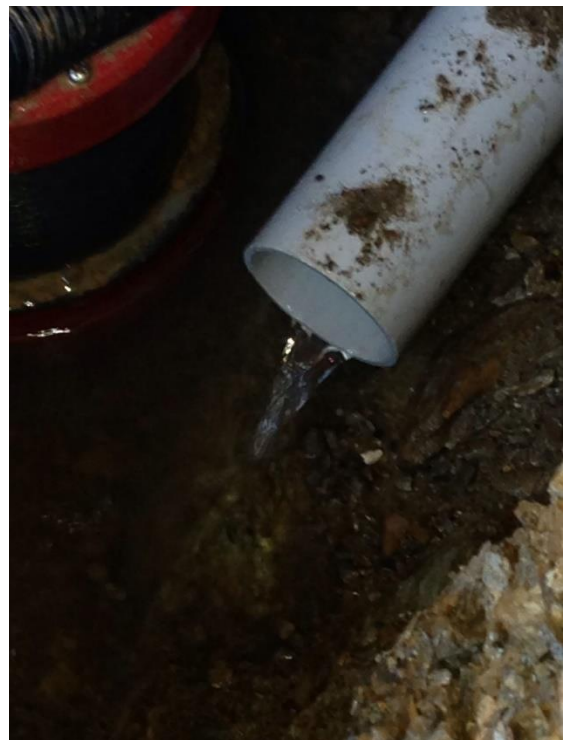
Discharge from the pipe under the slab, some 3-4 days after the slab had been poured. Note that there had been significant rain before the slab was laid but none since. Click on the image for video.
