# CASE STUDY

## BEHIND A SHOTCRETE BASEMENT WALL

**Location:** Pascoe Vale, Melbourne

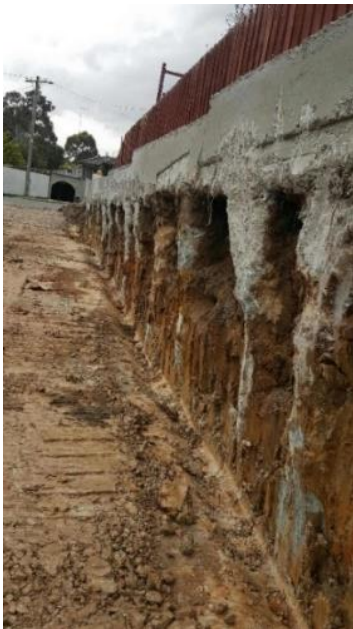
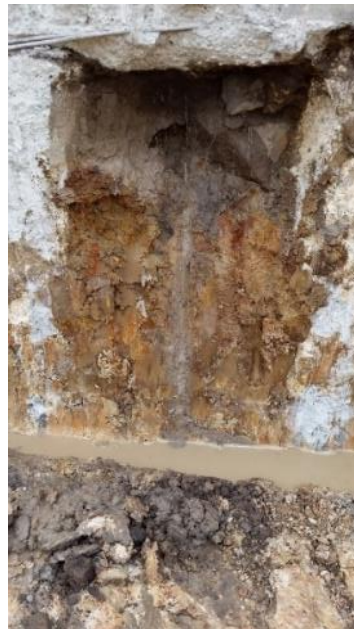
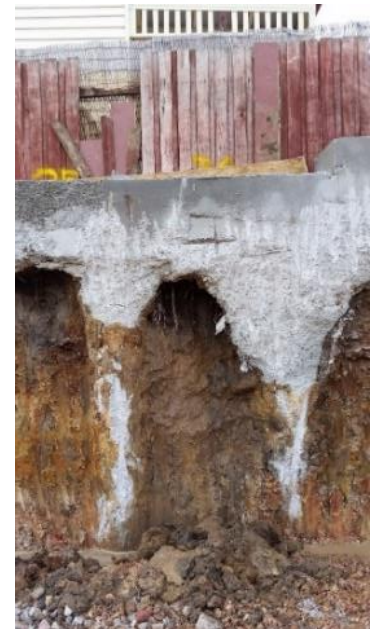
Click on the photos to see how the water coming from the adjacent property is flowing through the soil and is causing the soil to slump into the trench.

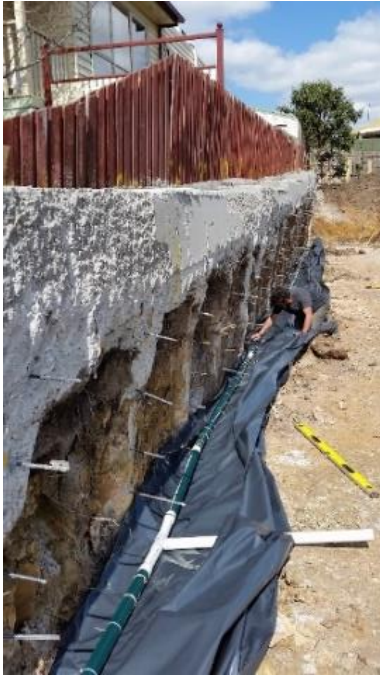
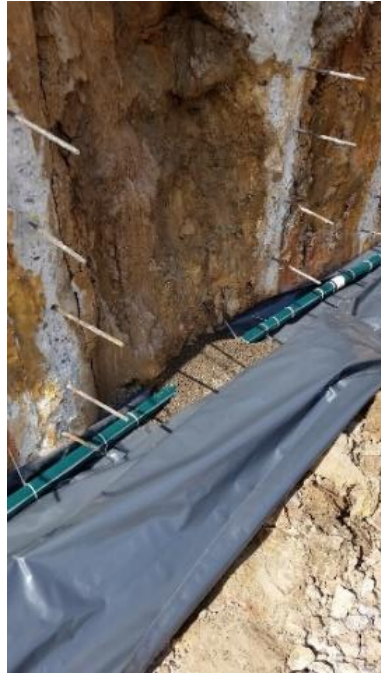
A 10-15 cm deep trench was excavated alongside the cut and filled with a layer of fine gravel which was then graded to achieve a 2% slope to the stormwater exit. Plastic sheeting was then laid over the gravel and Capiphon installed (as 3-metre pipes) and covered with another thin layer of gravel.

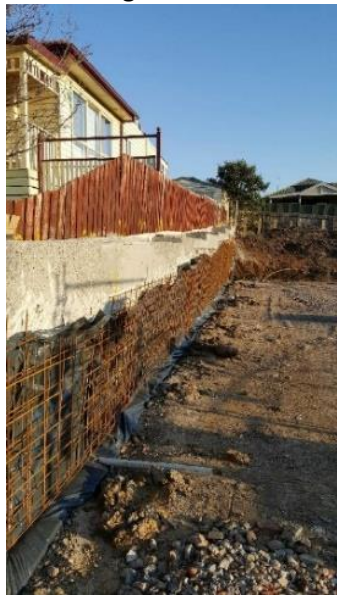
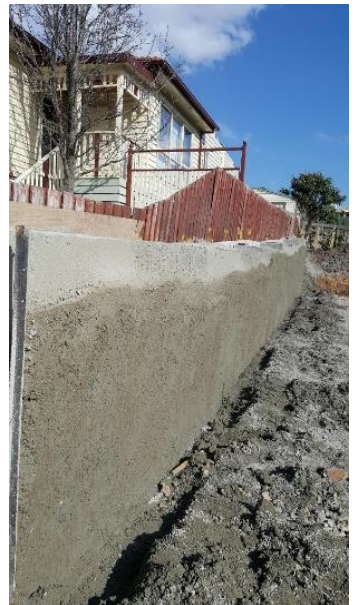
The plastic sheet was then folded back over the Capiphon and up the wall ready for construction of the steel mesh and subsequent shotcreting.
