CASE STUDY

Rock Seepage into Outside Laundry & Courtyard

Location: Hampden Road, Battery, Tasmania

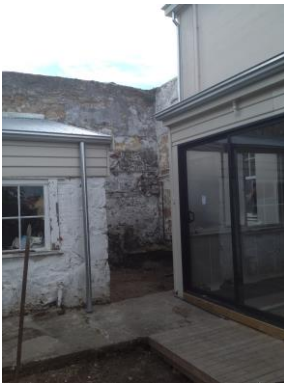
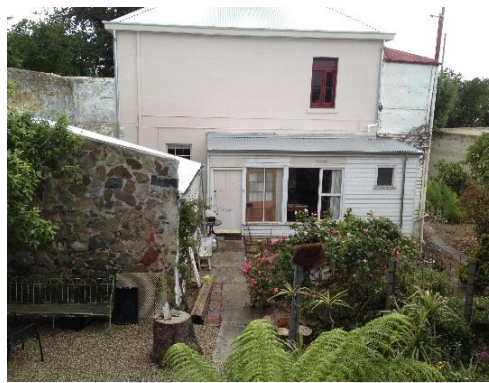
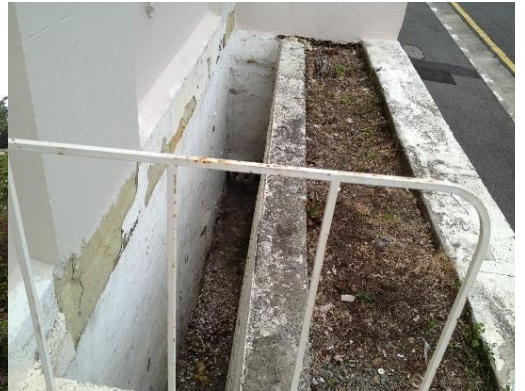
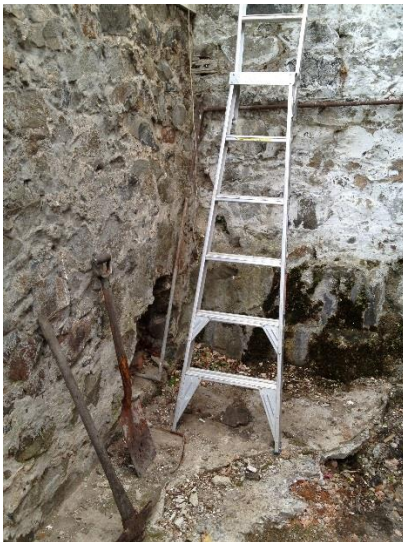
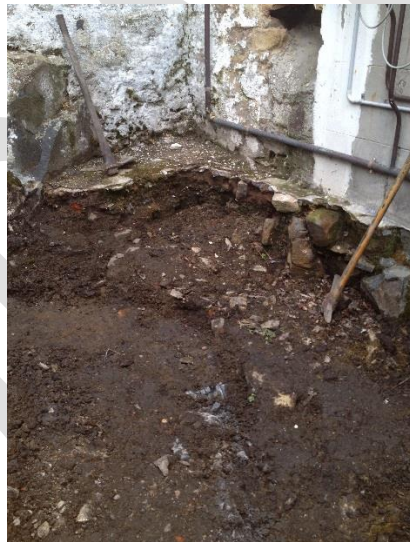
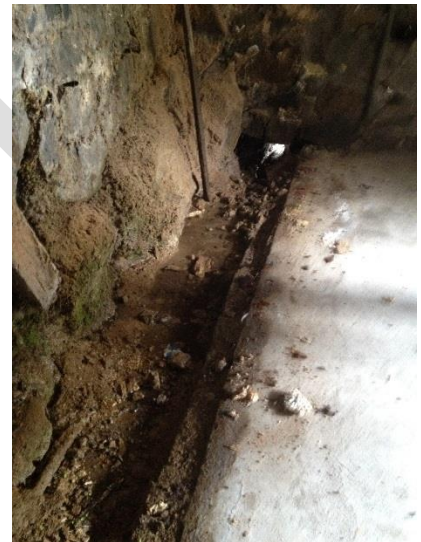
The house has been built on a rock bench at the foot of the old Hobart foreshore. Water seeps through the sandstone cliff face into the old outside laundry and into a partly enclosed courtyard. In heavy rain water flows from a deep drain (the Moat) designed to keep it away from the front of the house.

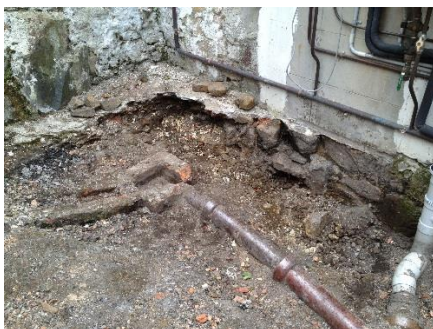
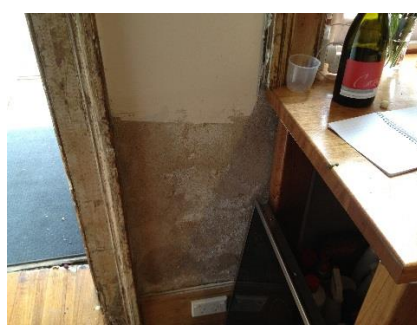
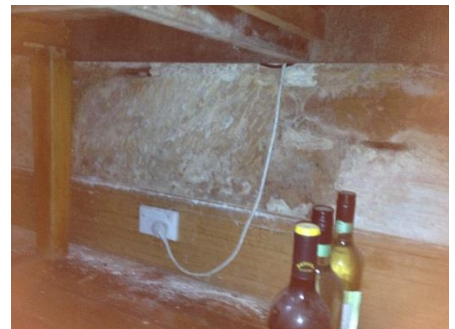
Despite attempts to control the situation with surface and sub-surface drainage, water has seeped under and through the sandstone foundations over the years causing rising damp in the ground floor rooms.
