CASE STUDY

Restricted Depth Rules Out Ag Pipe: Concrete Slab

Location	Bayside Drive, Lauderdale, Tasmania	
Problem	Water lying against the slab. It is feared that water will seep down between the foundation and the slab.

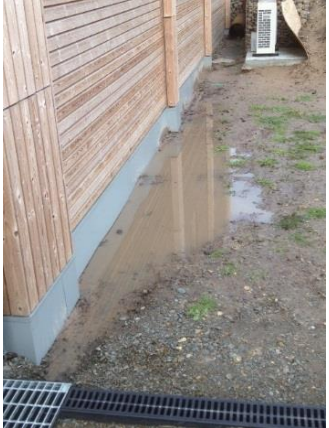
Diagnosis	<p>Water flows down the bank and pools against the slab because it cannot get away –</p> <ul style="list-style-type: none"> • The sump pit is too high to take surface drainage • The exit pipe from the sump is too high to allow water that might flow through an Ag Pipe to enter the pit. 	
Treatment	<ul style="list-style-type: none"> • Lay 10 metres of 10cm wide Capiphon belt along the foundation and adjacent to the slab. • Ensure 2% slope with thin layer of coarse sand. • Cut slot into side of the pit, and insert belt. <div style="text-align: center;">

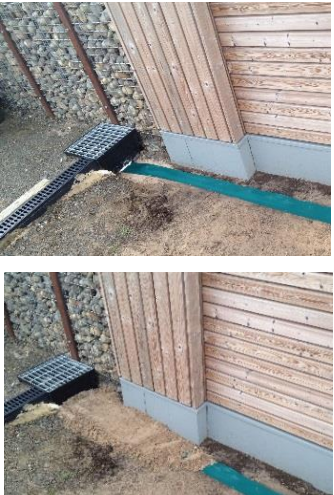
</div> <ul style="list-style-type: none"> • Cover with more sand. Restore surface with chosen material.

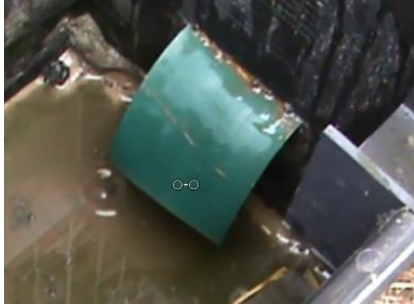
<p style="text-align: center;">Water dripping from Capiphon belt.</p>
