# CASE STUDY

## New Retaining Wall with Limited Depth Access

**Location:** Rosny Esplanade, Montague Bay, Tasmania

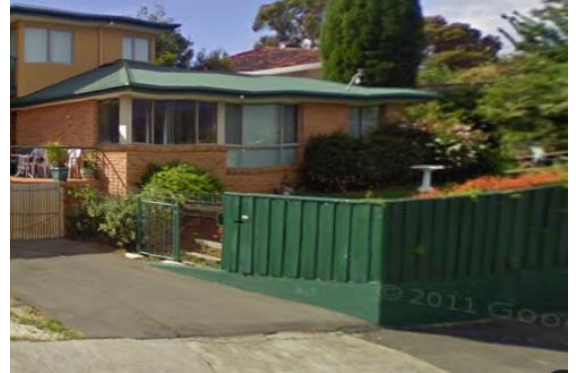
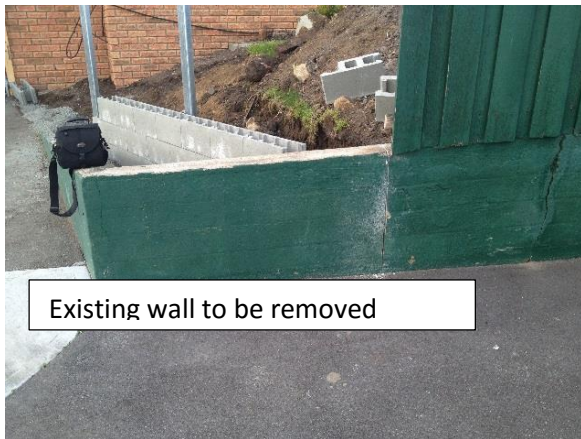
Existing wall to be removed

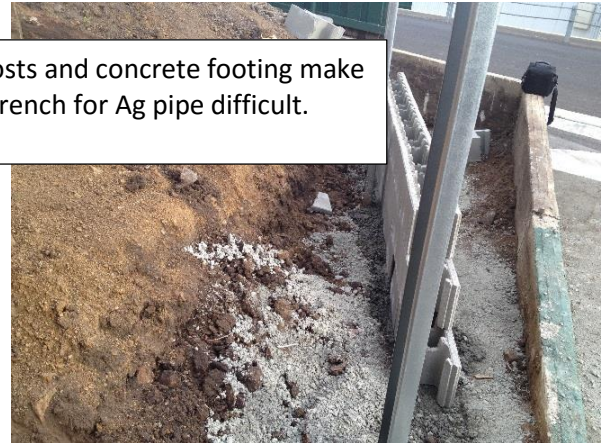
Fence posts and concrete footing make digging trench for Ag pipe difficult.

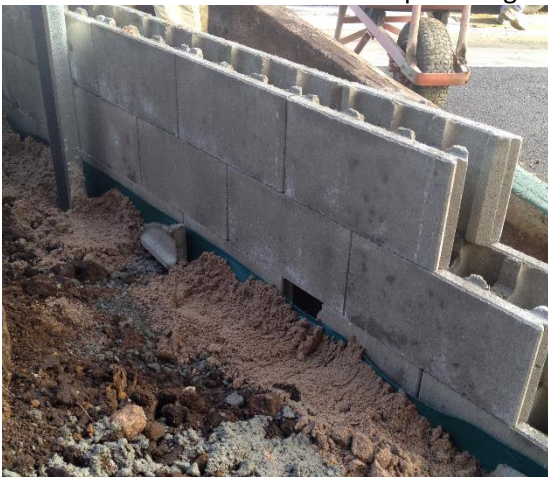
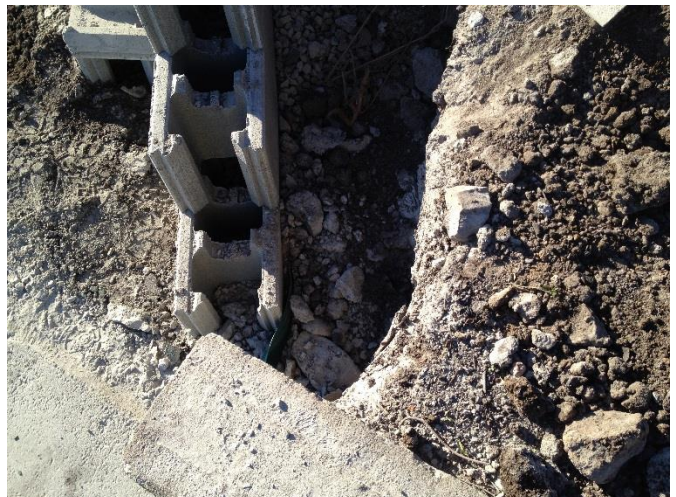
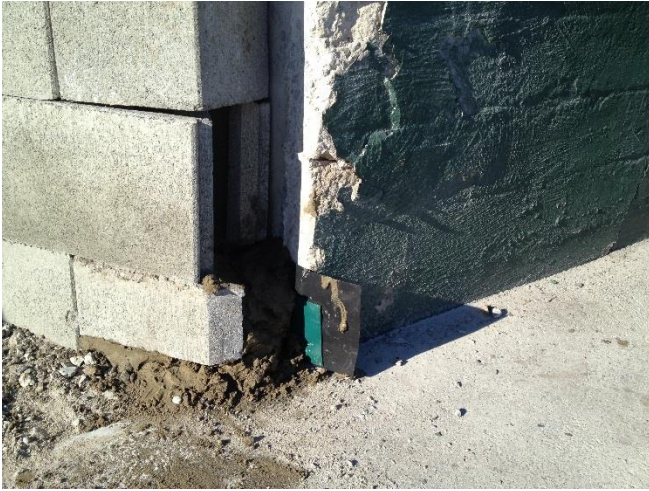
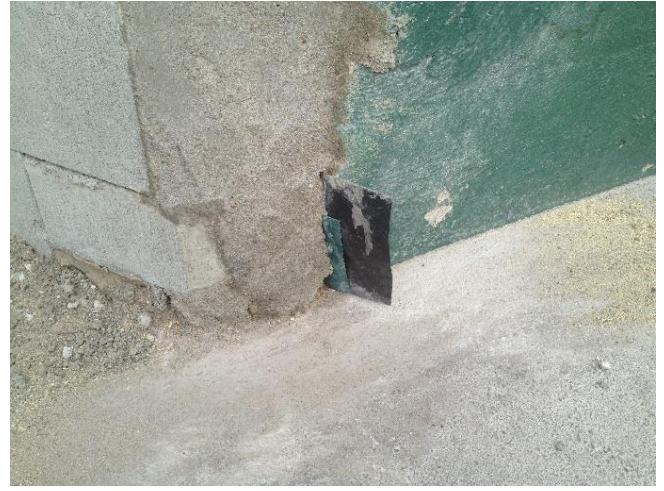
Capiphon belt was laid on its edge against the retaining wall, on a 5% slope towards the footpath. The belt was inserted into the gap between the old and new sections of the retaining wall. The smooth side of the belt was placed against the wall, while the grooves were faced towards the soil. The belt was held in place by pieces of broken brick while coarse sand was placed against the belt before the void was backfilled.
