CASE STUDY

Waterproofing & Boundary Issues

Location: Greenway Avenue, Lenah Valley, Tasmania

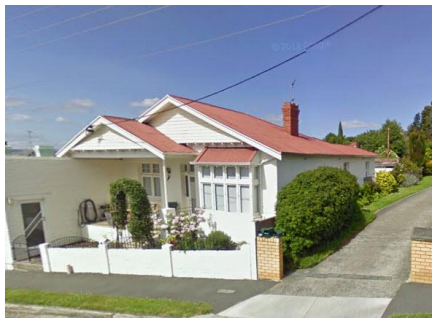
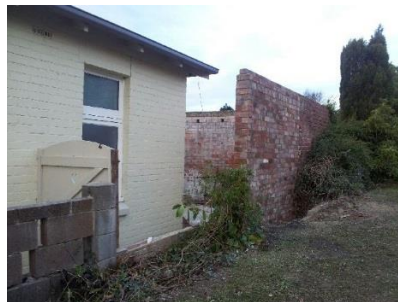
An owner-builder engaged an architect to design an extension to his 1930s suburban house utilising part of an existing outbuilding. Difficulties arose when the building surveyor pointed out that the walls of the outbuilding to be retained were, in fact, right on the boundaries of two neighbouring properties. This meant that the proposed drainage around the new extension would not be possible because it would have to be sited on the adjoining properties.

The owner was faced with the prospect of pulling down the walls and building new walls with drainage on the outside, not to mention the cost of new boundary fences. The major disappointment, though, would be the loss of space in the new room.

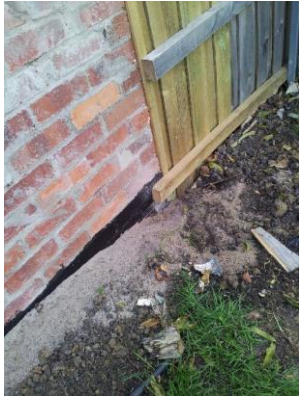
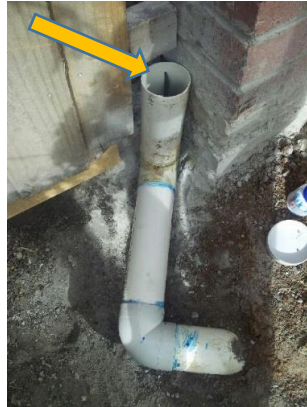
The Capiphon belt from the neighbour's side hidden by sand; the belt poking between the wall and the fence, and into the stormwater pipe (arrow); and the finished job.
