CASE STUDY NEW SAND TRACK

Location: Dubbo

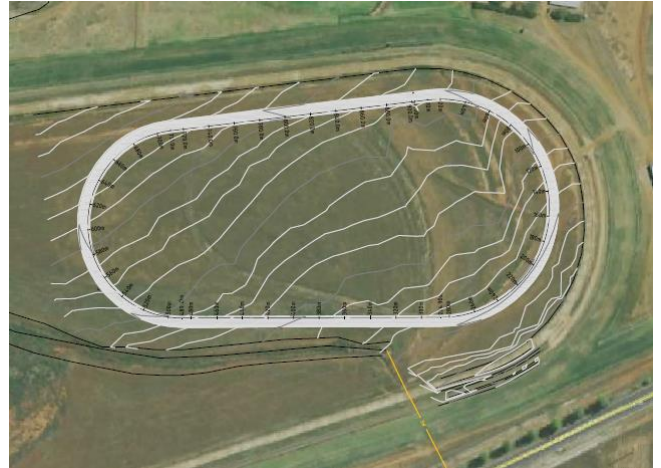
DETAIL C
SCALE 1:50 (A3)

The track will be composed of 125mm of coarse sand laid on a compacted subbase, and held in place by a 50mm thick wooden plinth. The design calls for drainage through a 50mm diameter ag pipe which exits through the plinth every 20m.

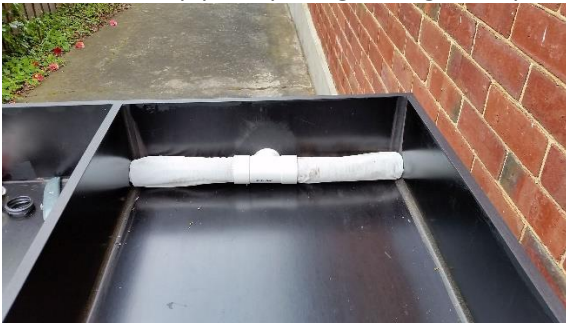
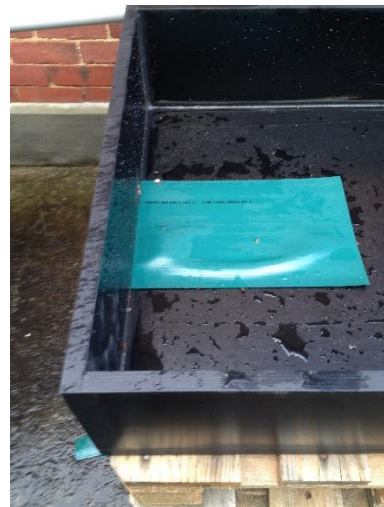
A model was constructed from form plywood; two equal compartments, 1150mm by 957mm, and 1500 deep, one containing ag pipe as specified, the other with 600mm of Capiphon poking through the 'plinth'.

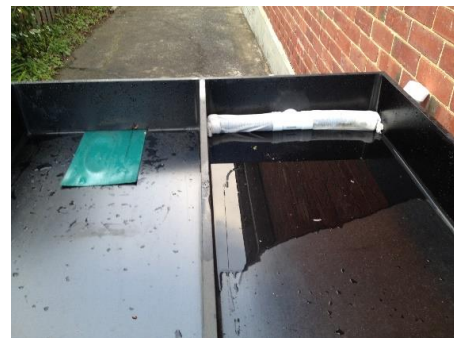
Initial tests without the sand showed,

1. Flow rates were equivalent. (Direct comparisons is not possible given the differences in opening ratios and length of belt/pipe in contact with water)
2. That Capiphon completely drained the tank, while a considerable amount of water remained in the ag pipe tank as shown by the water table.

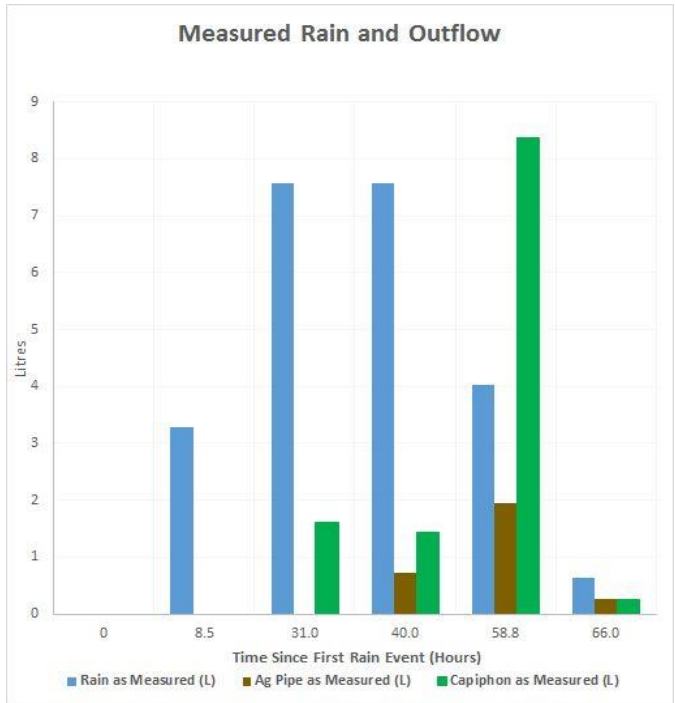
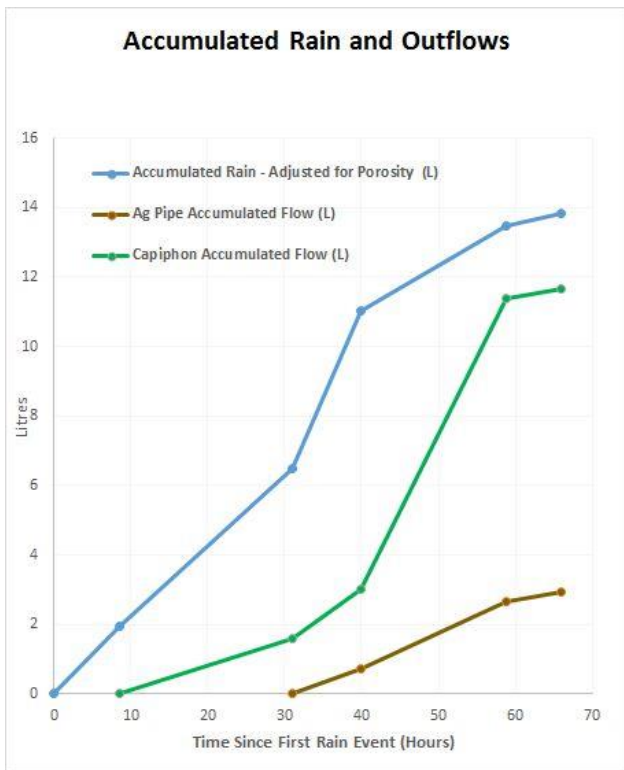
When filled with sand, the results were even more striking. Water from the first rain event was completely taken up by the voids in the sand, but then began to flow from the Capiphon belt after the second rain event. Water did not appear from the ag pipe until several hours later, by which time even more had been delivered by Capiphon.

Rain continued over the next few days and it would appear that Capiphon drained rain from the tank continuously, thus making way for more water to be collected.

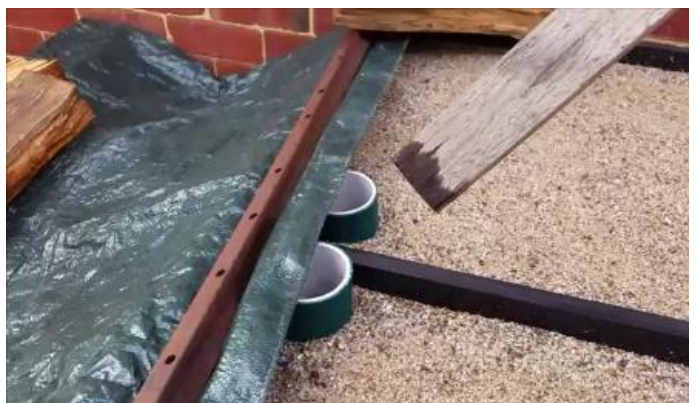
At the end of the trial there remained a significant volume of water in the ag pipe tank, and when the sand was removed some two days later, it still appeared to be very wet compared to that in the Capiphon section.

Total drained by Capiphon	8.7 Litres
Total drained by ag pipe	2.9 Litres
